App Note #183 AT&T 3G Sunset - MultiTech

APPLICATION NOTE #183

AT&T 3G Sunset 4G Device Impact - Multitech

DATE: 11-January-22

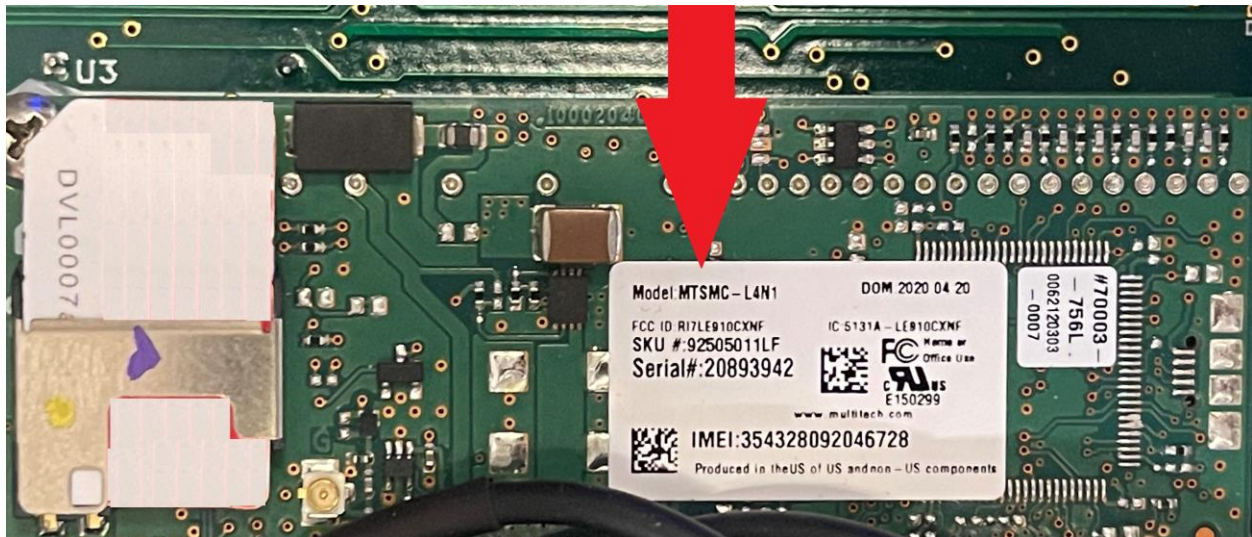
The model number can be located on the front of the cellular module. Only the two models listed below when using an AT&T SIM card require this update.

- MTSMC-LAT3
- MTSMC-L4N1
